**SUBJECT**  
St Nicholas – Bat Tree Climbing Report

**DATE**  
15/05/2023

**OUR REF**  
B10181-0AG964-ZZ-ZZ-ME-NB-ED0286

**PROJECT NUMBER**  
10048098

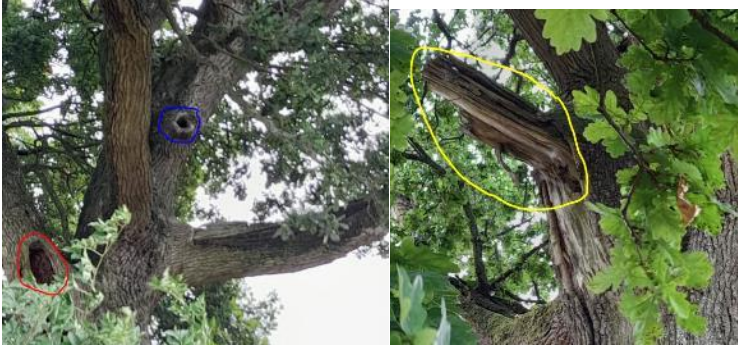
| Tree Number and species | Survey Type | Feature | Result |
|---|---|---|---|
| 6 Oak | Extendable endoscope, ladder and rope | A - Knot hole | All features filled with water and considered unsuitable for roosting bats |
| | | B - Split branch | |
| | | C - Large cavity (south) | |
| | | D - Large cavity (north) | |

| Tree Number | Feature | Photograph |
|---|---|---|
| 6 Oak | Knot hole (blue) | |
| | Split branch (yellow) | |
| | Large cavity (south – no photo) | |
| | Large cavity (north - red) | |

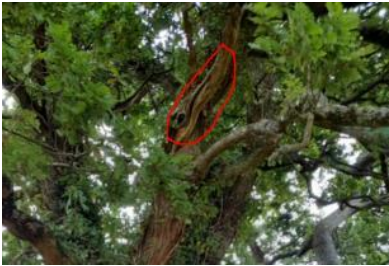
| Tree Number and species | Survey Type | Feature | Result |
|---|---|---|---|
| 7 Oak | Extendable endoscope, ladder and rope | A - Split beam | Moderate potential but no evidence of bats |

| Tree Number | Feature | Photograph |
|---|---|---|
| 7 Oak | Split beam (red) | |

It is recommended that a further emergence survey is undertaken on Tree 5, 7, 10 and 11 between May and September in line with guidance<sup>1</sup>.

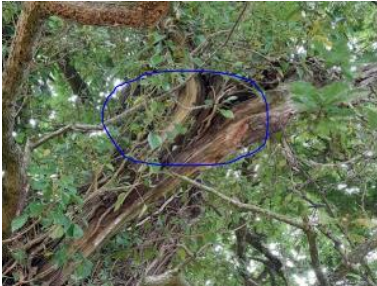
| Tree Number and species | Survey Type | Feature | Result |
|---|---|---|---|
| | | B - Split limb (west, 4m high) | Moderate potential but no evidence of bats |

| Tree Number | Feature | Photograph |
|---|---|---|
| | Split limb (west, 4m high, blue) | |

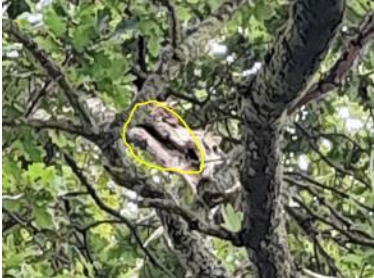
| Tree Number and species | Survey Type | Feature | Result |
|---|---|---|---|
| | | C - Split limb (west, 12 m high) | Moderate potential but no evidence of bats |

| Tree Number | Feature | Photograph |
|---|---|---|
| | Split limb (west, 12 m high, yellow) | |

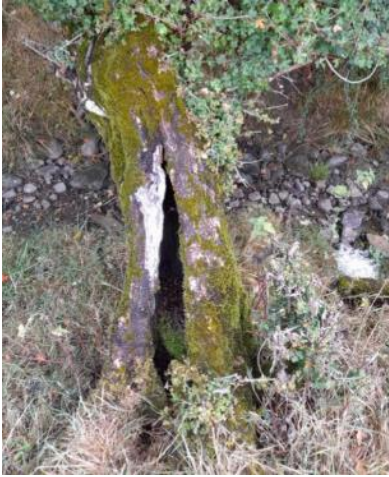
| Tree Number and species | Survey Type | Feature | Result |
|---|---|---|---|
| 10 Hawthorn | Extendable endoscope | Buttress rot cavity | Moderate potential as a day roost |

| Tree Number | Feature | Photograph |
|---|---|---|
| 10 Hawthorn | Buttress cavity | |

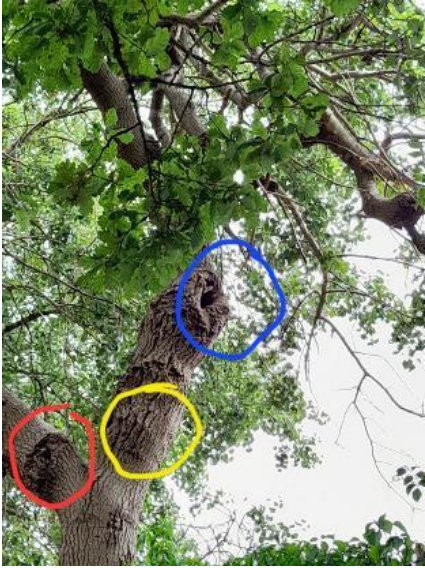
| Tree Number and species | Survey Type | Feature | Result |
|---|---|---|---|
| 11 Aspen | Extendable endoscope, ladder and rope | A – knot hole | No depth to support bats |
| | | B – bark fissure | No depth to support bats |
| | | C – knot hole | The knot hole extends into a cavity 15cm deep, and 30cm up and 30cm down the trunk. Moderate potential. |

| Tree Number | Feature | Photograph |
|---|---|---|
| 11 Aspen | Knot hole (blue) | |
| | Bark (yellow) Fissure | |
| | Knot hole (red) | |

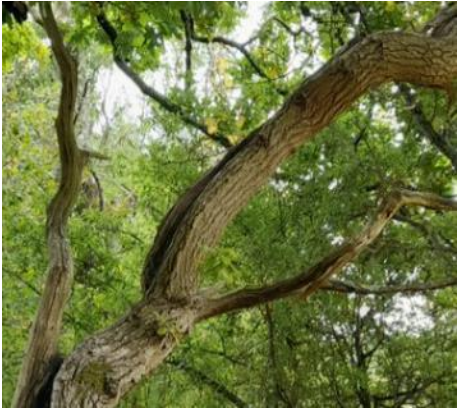
| Tree Number and species | Survey Type | Feature | Result |
|---|---|---|---|
| 12 Oak | Extendable endoscope | Split limb | No suitable features |

| Tree Number | Feature | Photograph |
|---|---|---|
| 12 Oak | Split limb | |

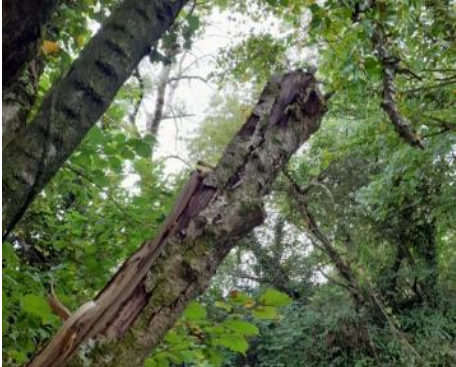
| Tree Number and species | Survey Type | Feature | Result |
|---|---|---|---|
| 14 Hazel | Extendable endoscope | Split stem | No suitable features |

| Tree Number | Feature | Photograph |
|---|---|---|
| 14 Hazel | Split stem | |
