## Let's Stop the Block

## Cardiff – Sewer Abuse Case Study

## Cowbridge – Sewer Abuse Case Study

## Llandudno Pumping Station – Sewer Abuse Case Study

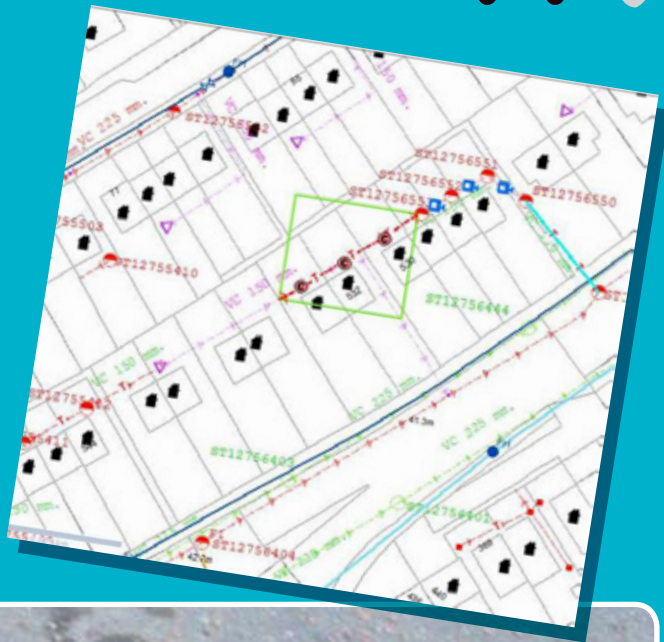
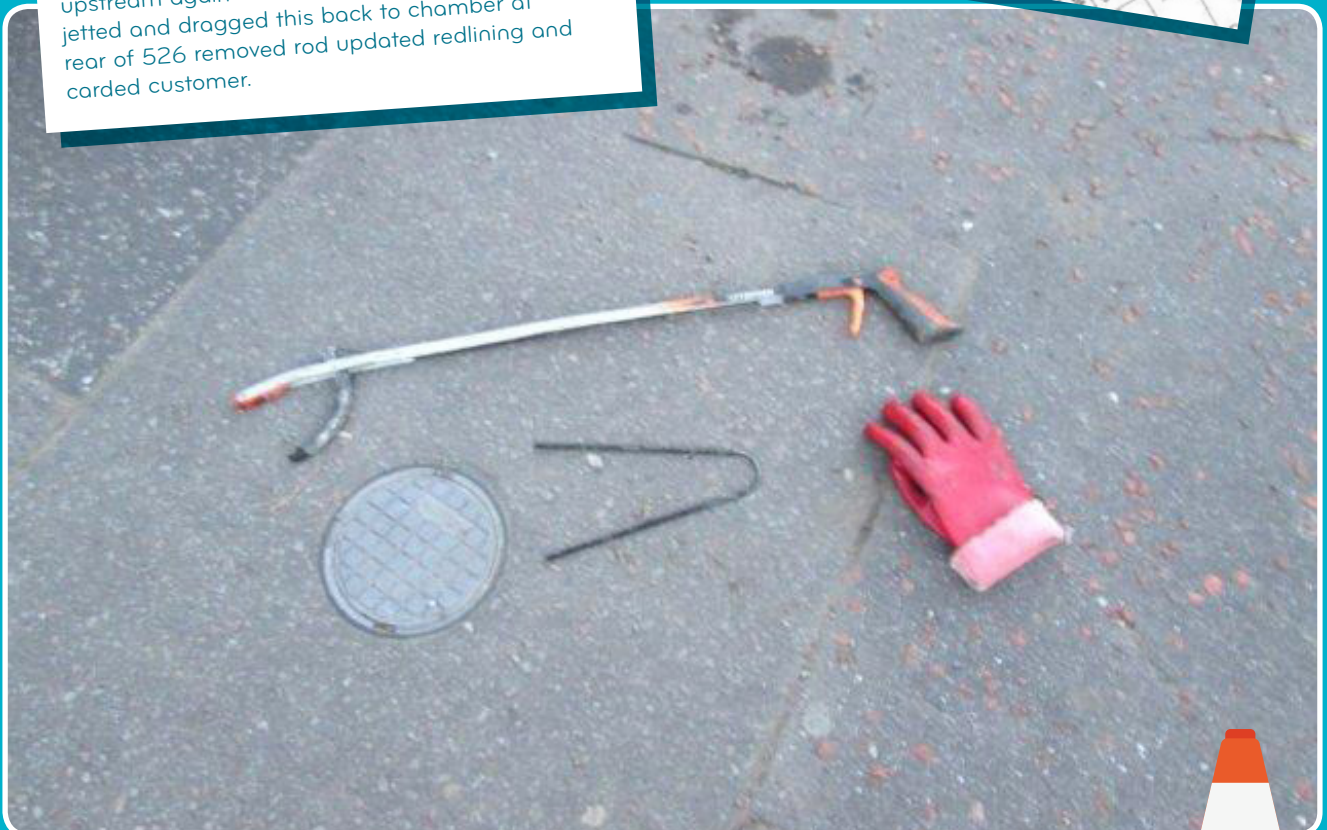
Metal bar

Jetted upstream from ST12756551 clear blockage then dragged line pulled back large piece of metal then looksee broken pipe and large piece of concrete wash in line, surveyed upstream found concrete wash in line, jetted upstream with warthog and tried to cut out concrete some still left in line took photo survey upstream again found bent metal rod in line jetted and dragged this back to chamber at rear of 526 removed rod updated redlining and carded customer.

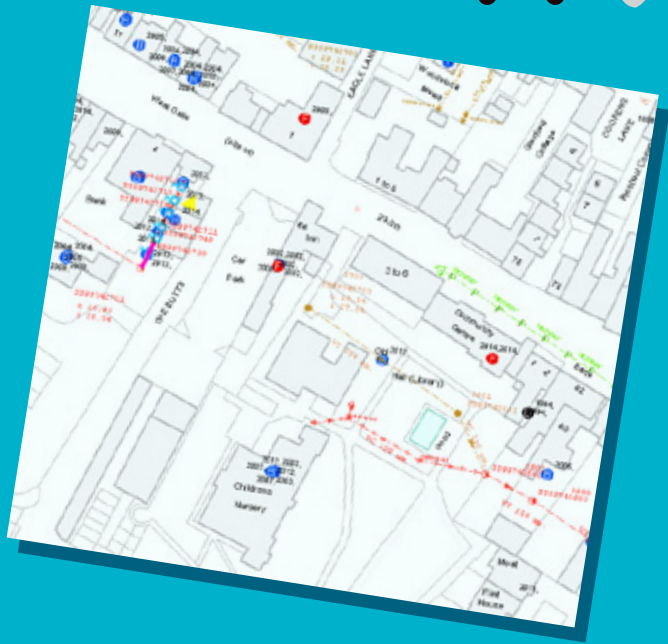
**Description:**  
Inspected manhole SS99742703, which was full of FOG. Checked downstream manhole SS99743601, which was clear. Set up on SS99743601 and jetted upstream approximately 50m. Line full of solid FOG from 5m - 50m. Was able to clear blockage with warthog and full tank of water, however, the line blocked up further downstream due to the amount of fat. Traced resulting blockage downstream to SS99743605 on Church Rd, some 150m away and cleared. Have jetted with warthog some 200m in total to restore full flow. Customer said he had to shut down and lost £3000 in takings due to smell and no use of toilets for customers.

**Below left:**  
Chamber blocked with fat, oil and grease

**Below right:**  
Chamber during difficult blockage clearance showing sludge of FOG compounds

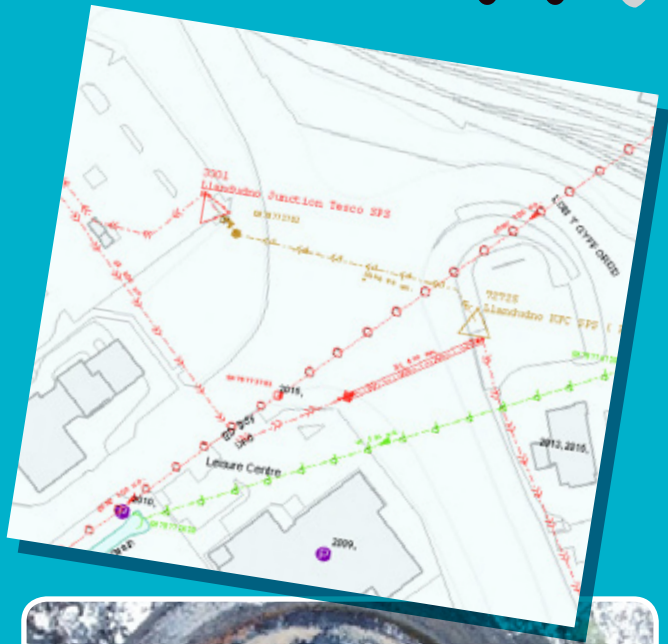
The wet well at the Tesco SPS was full of FOGs and it took 2 GEWS tankers and a man entry into the wet well to dig out approx. 4ft of solid FOGs. GEWS were on site for 4 hours cleaning out the well and both GEWS and Nomenca said it was the worst well they had ever seen. The pumps were also fogged up and as a result we need to replace the impellers.
