Dŵr Cymru
Welsh Water

St Nicholas Wastewater Treatment Works Bat Survey Report July 2023

Arcadis Consulting (UK)
Limited
B10181-0AG964-ZZ-ZZ-RP-
NB-ED0246

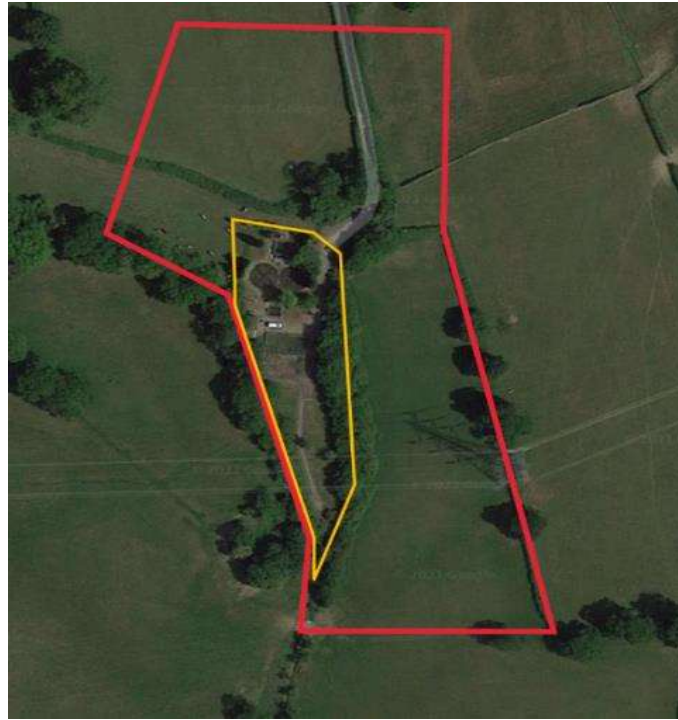
Figure 1: Aerial image of St Nicholas WwTW (approx. yellow line boundary) and the proposed development boundary (approx. red line boundary).

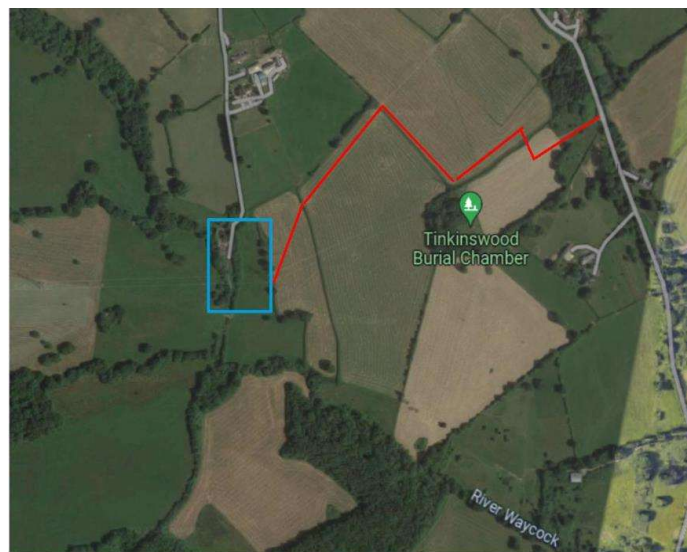
Figure 2: Aerial image of St Nicholas WwTW. Temporary access track highlighted in red and the approximate location of the WwTW works and extension is highlighted in blue.

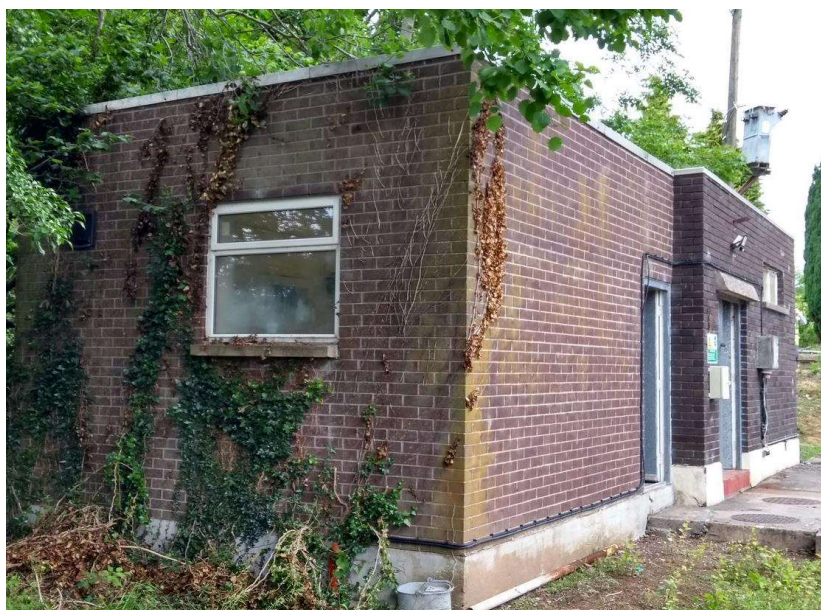
The ecological constraints walkover survey undertaken in June 2021 identified one PRF on the north-western aspect of the building adjacent to the fence line and trees (a photograph of the building is provided as Figure 3 below). The feature (gap between fascia board and the building) was considered to have low bat roost potential and would therefore require a single bat presence/absence survey between May and September as per BCT guidelines¹².

Figure 3 - Welfare building located within existing WwTW.

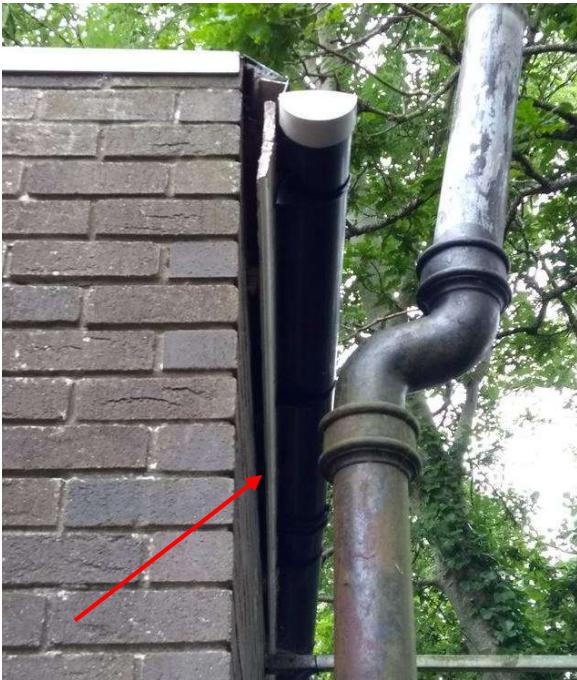
Three common pipistrelle bats were recorded emerging from the WwTW building during the August 2022 survey, see location of the roost in the image below. As the building was identified as a bat roost, an additional survey was required to confirm the type of bat roost the building supported, and an additional bat survey was undertaken in June 2023. No bats were observed entering the building during the dawn re-entry

survey. The results of the surveys indicate that the building is an occasional day roost for a small number of common pipistrelle bats during the summer.

Figure 4: Location of bat roost

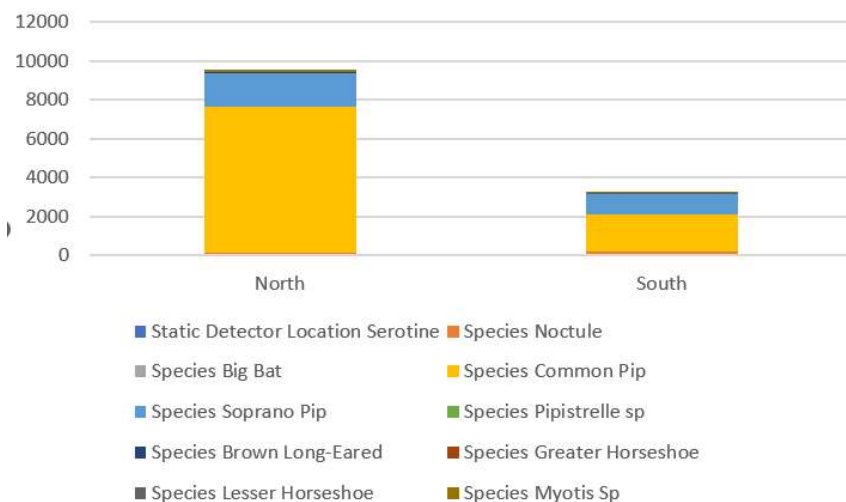
Figure 6: Summary of total static bat survey results from August to October 2022 and April to June 2023 (see Appendix A for monthly breakdown).

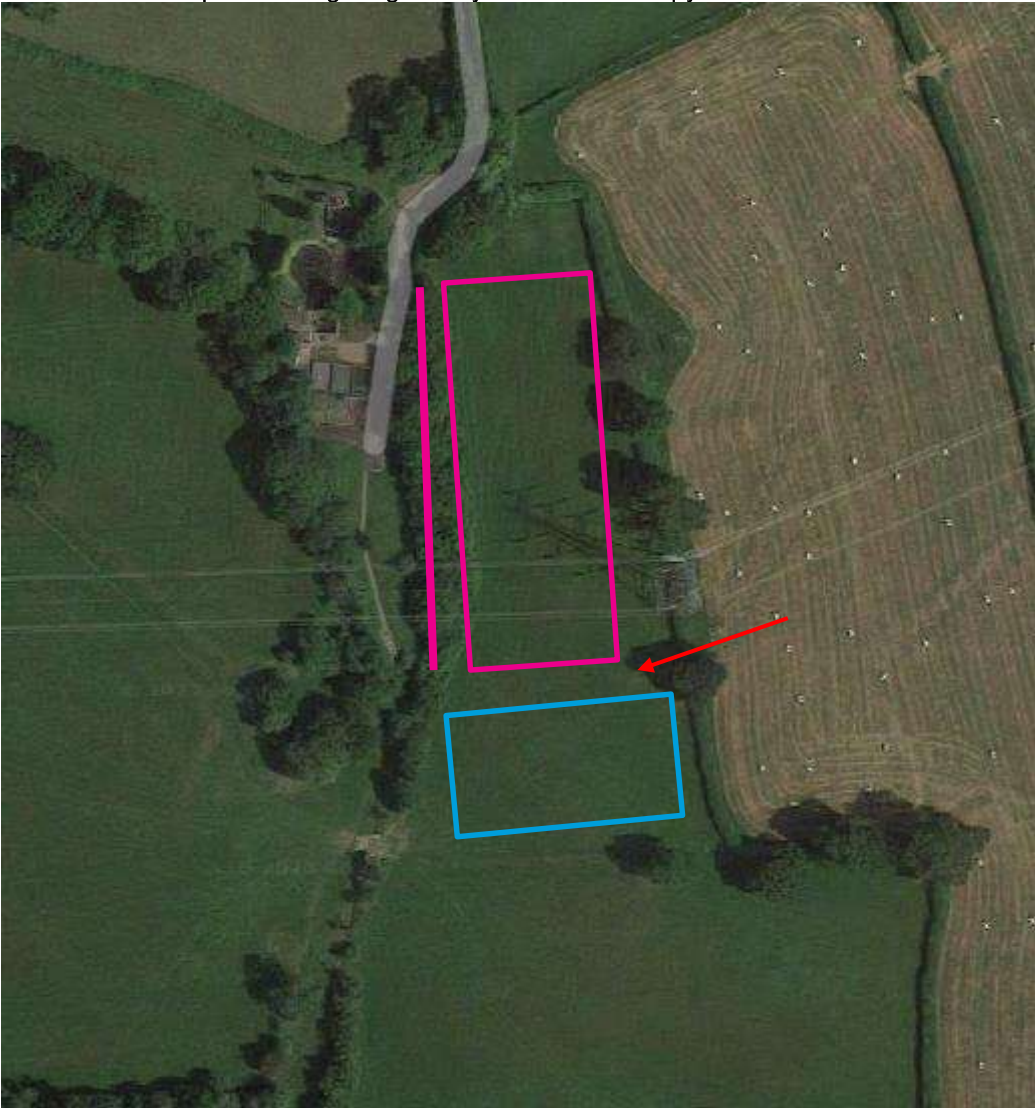
The proposed works will result in the removal of one tree line (approximately 100m) and the loss of approximately 0.5 hectare of grassland habitat to allow the expansion of the WwTW as shown on Figure 7. The construction compound may also result in temporary damage to grassland habitat and the temporary access track will pass through a gateway under the canopy of Tree 5.

Figure 7: Proposed works and impacts (pink – likely extent of vegetation lost to the WwTW expansion, blue – temporary construction compound area, red arrow – access through gate under canopy of tree T5).

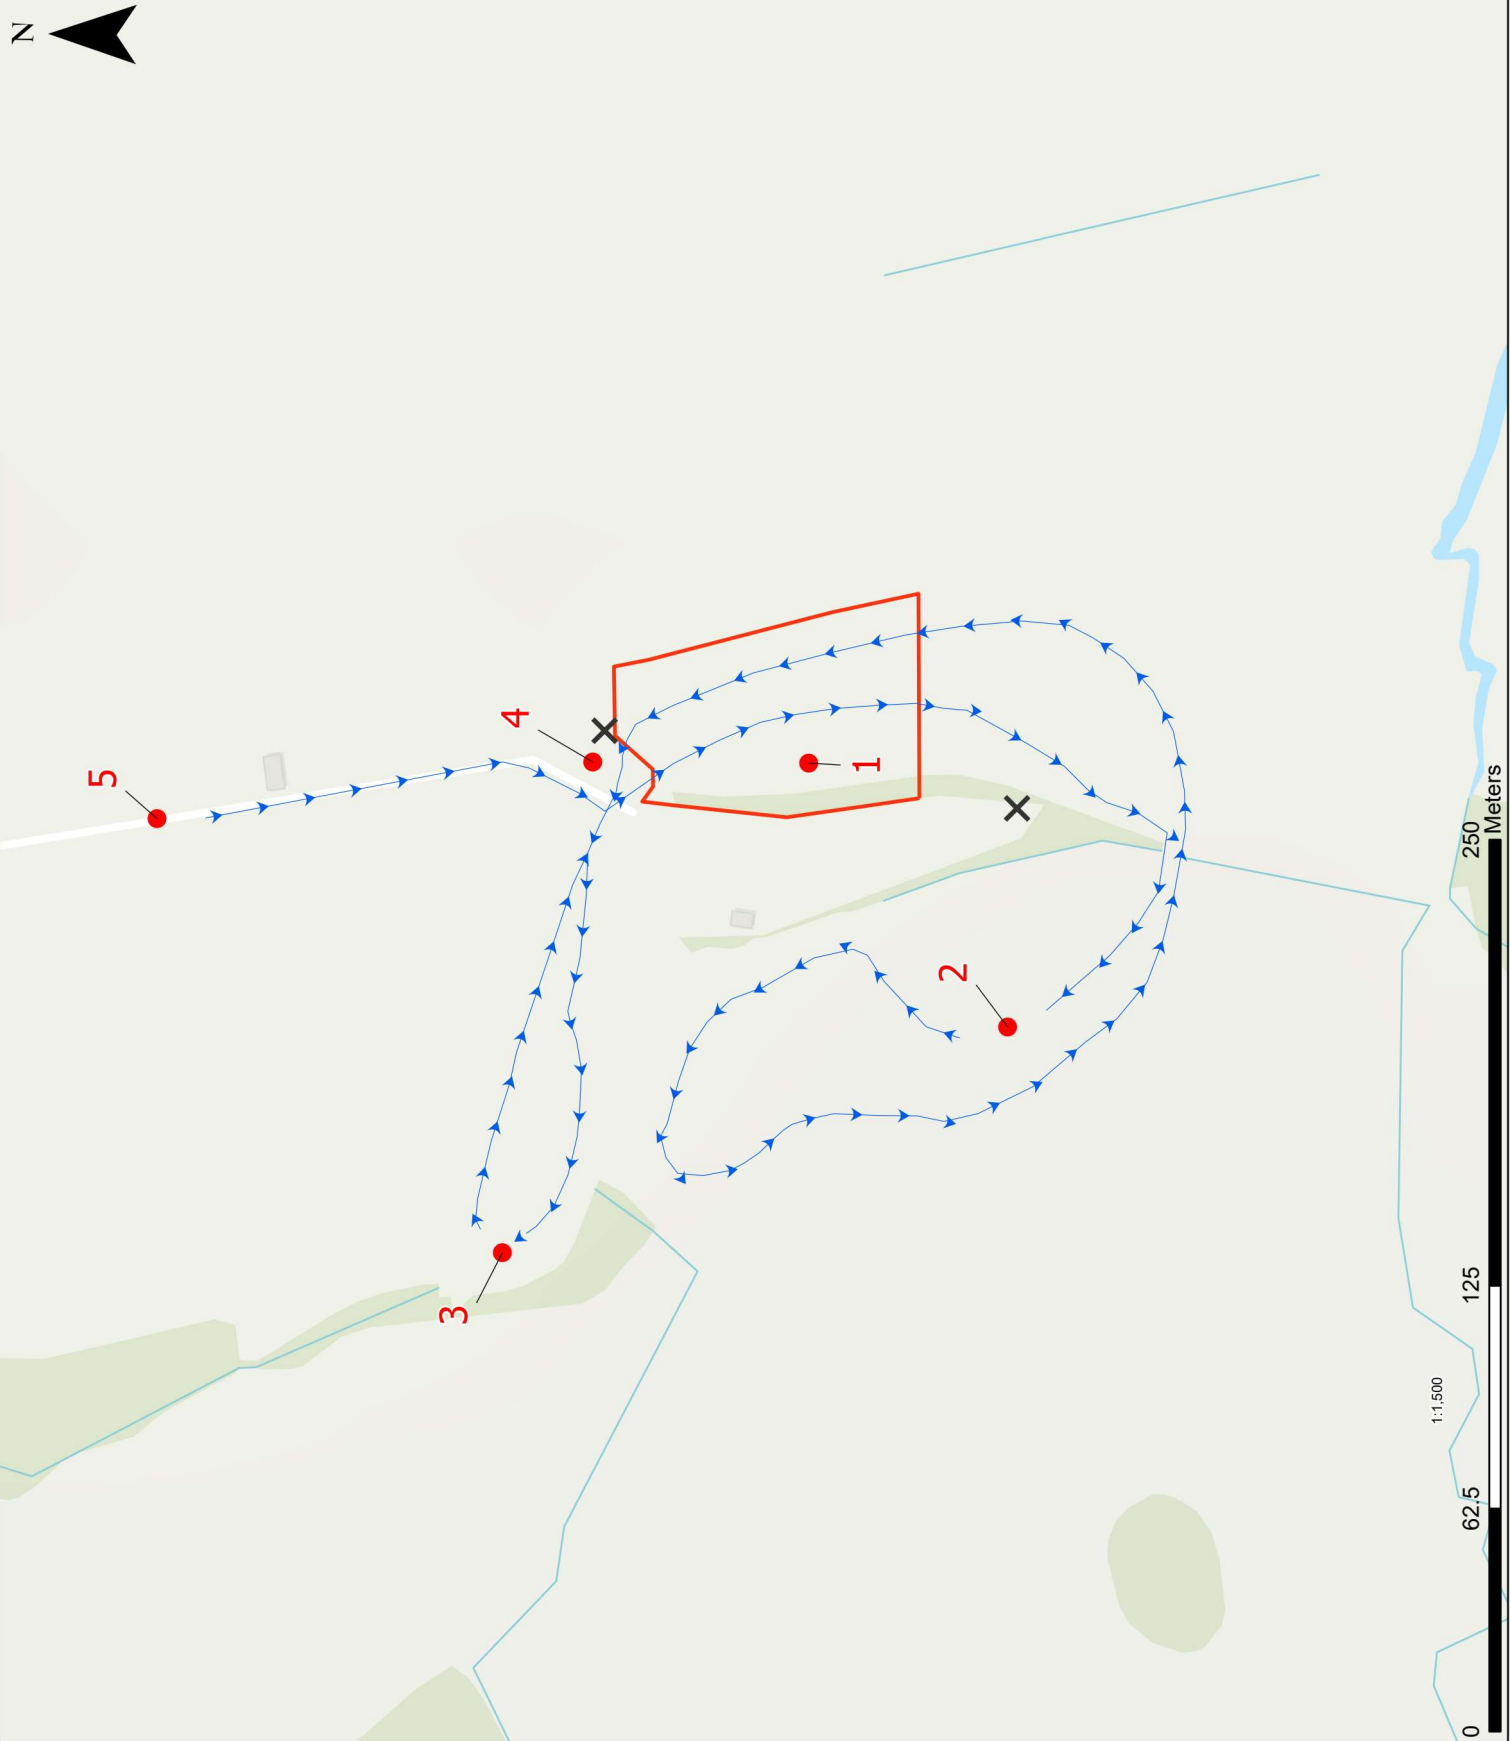
DRAWING B10181-0AG964-ZZ-ZZ-DR-NB-ED0249

Static Locations and Activity Transect Plan

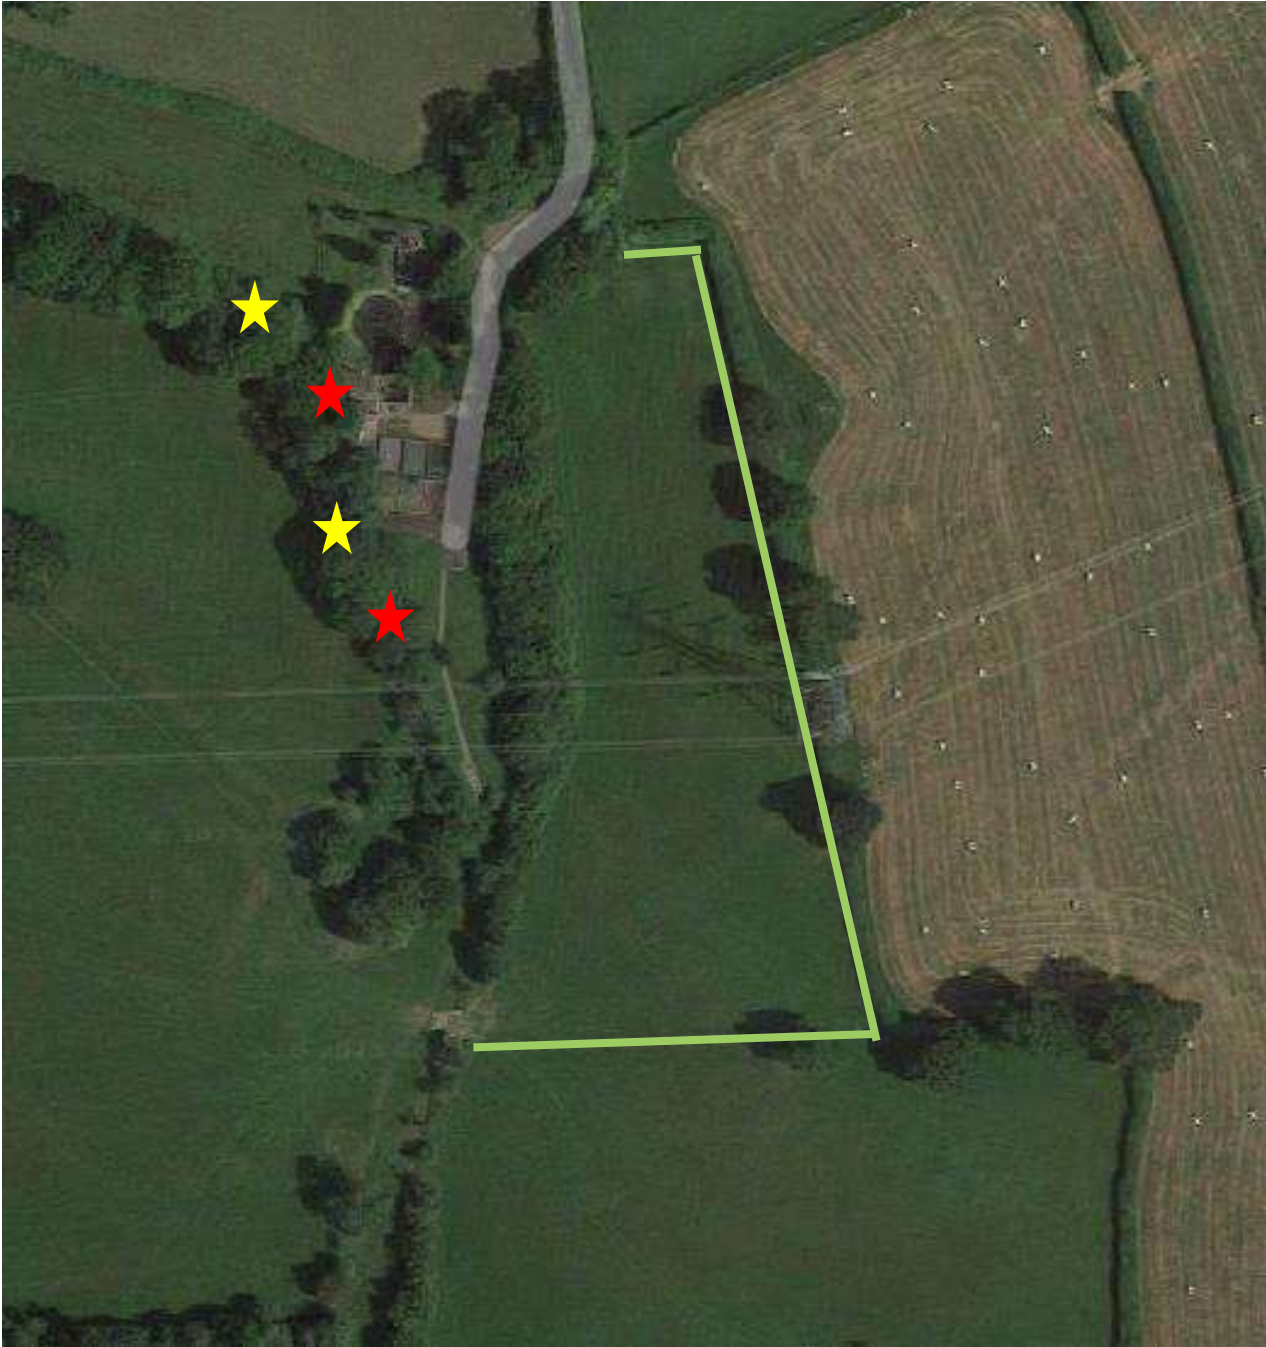
Figure 7 - Proposed mitigation plan (green line = tree planting, yellow stars = bird box locations, red stars = bat box locations)

- Landscaping should include bat friendly plants i.e., night-time scented flowers that attract invertebrates suitable for bats to forage.
- Trees should be planted to form a west to east corridor immediately south of the compound area to replace the trees that need to be removed at the centre of the site. Semi-mature trees should be planted to provide an instant dark wooded corridor for bats. Scattered broadleaved trees should also be planted along the eastern boundary of the site to enhance it for commuting bats and create a dark wooded (see Appendix C).
