## **Llanishen & Lisvane Reservoirs Crayfish Survey**

**Dŵr Cymru Welsh Water**

**APEM Ref: P00002816**

**September 2018**

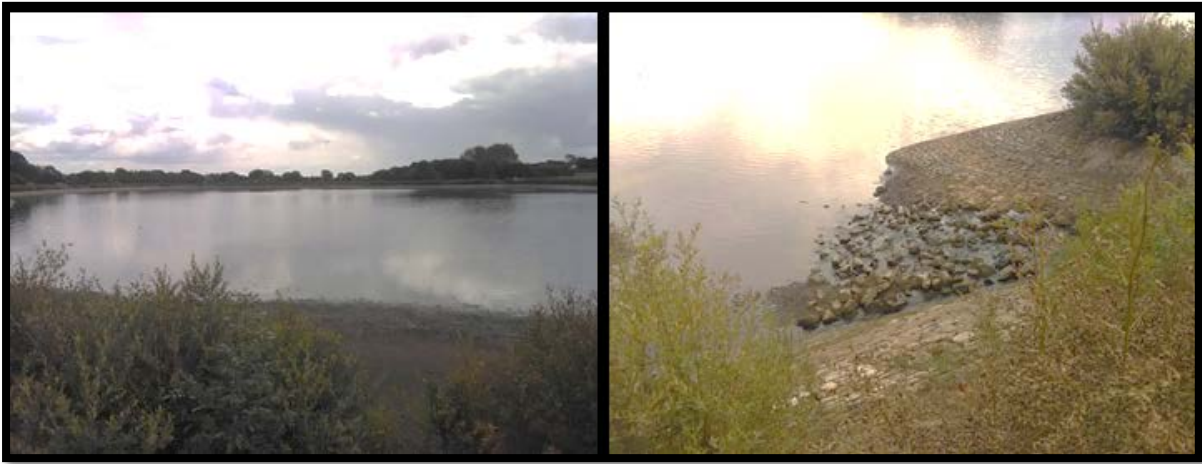
**Figure 2 Lisvane Reservoir, looking east. Steep & walls and boulder on margins of reservoir**

At the time of survey Lisvane Reservoir was considerably drawn down by approximately 2.5 m, following extremely dry antecedent conditions, resulting in exposure of steep walls and soft banks on the reservoir margins. Reservoir crayfish habit was generally poor with large silted areas blanketing most areas; however pockets of boulder and large cobble margins remained (Figure 2). Water depth was variable throughout the reservoir.

With its very low water levels at the time of the survey, the generally poor quality of the habitat observed at Lisvane Reservoir is thought to be a contributory factor to the apparent lack of crayfish at the site. Deep, fine-grained, unconsolidated sediment accumulations were the principal constituent of the substrate in most locations. This is known to be undesirable for all crayfish species and would greatly reduce the potential carrying capacity of the reservoir in its drawn down condition (Peay 2003). The marginal boulder constituents of the reservoir walls would however constitute good habitat with ample refuge between the structures. This habitat was however, generally exposed during the survey. Whilst the manual searches of these refuges at a variety of locations returned no crayfish catch there is potential for these areas to offer ideal habitat for crayfish, notably when water levels are higher in the reservoir.

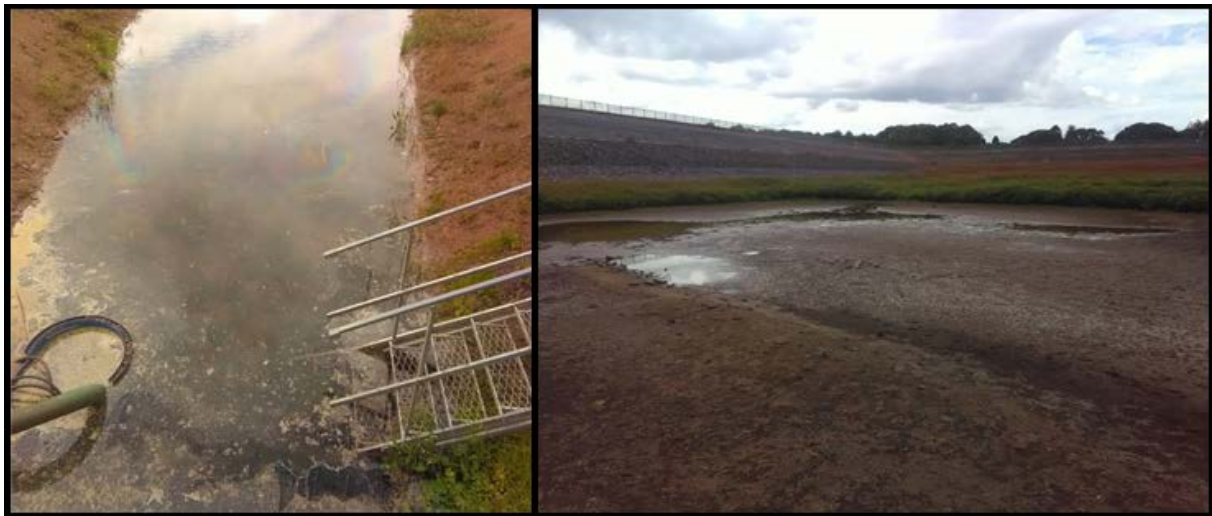
**Figure 3 Llanishen Reservoir, almost completely dry. Steep walls and soft sediment.**

As a result of ongoing engineering works, Llanishen Reservoir was fully drawn down at the time of survey, the only wetted areas remaining were a small channel of maximum depth 0.5 m in (Figure 3, left) and some extremely shallow pools (Figure 3, right). Soft substrate blanketed the wetted area and margins, providing little suitable crayfish habitat.

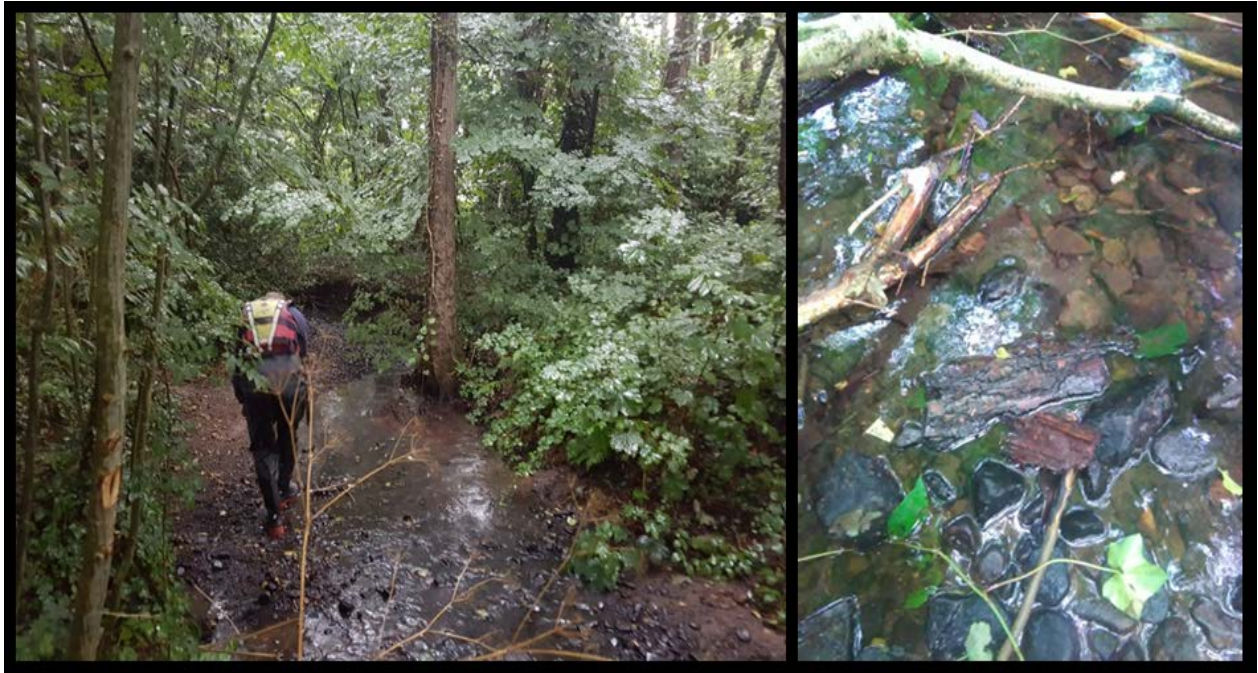
**Figure 4 Nant Fawr upstream of the reservoirs. Suitable crayfish habitat included fine roots (left) and large cobbles and woody debris (right).**

During the crayfish survey the wetted channel was reduced following extremely dry antecedent weather conditions and the previously wetted banks extended across half of the channel. The survey reach consisted mostly of shallow run with some shallow glide and riffle. Crayfish refuges were present, including boulders and cobbles, fine and large roots, undercut banks and accumulations of woody debris (Figure 4). The condition of the aquatic habitat in the reach was good with minimal sedimentation recorded.

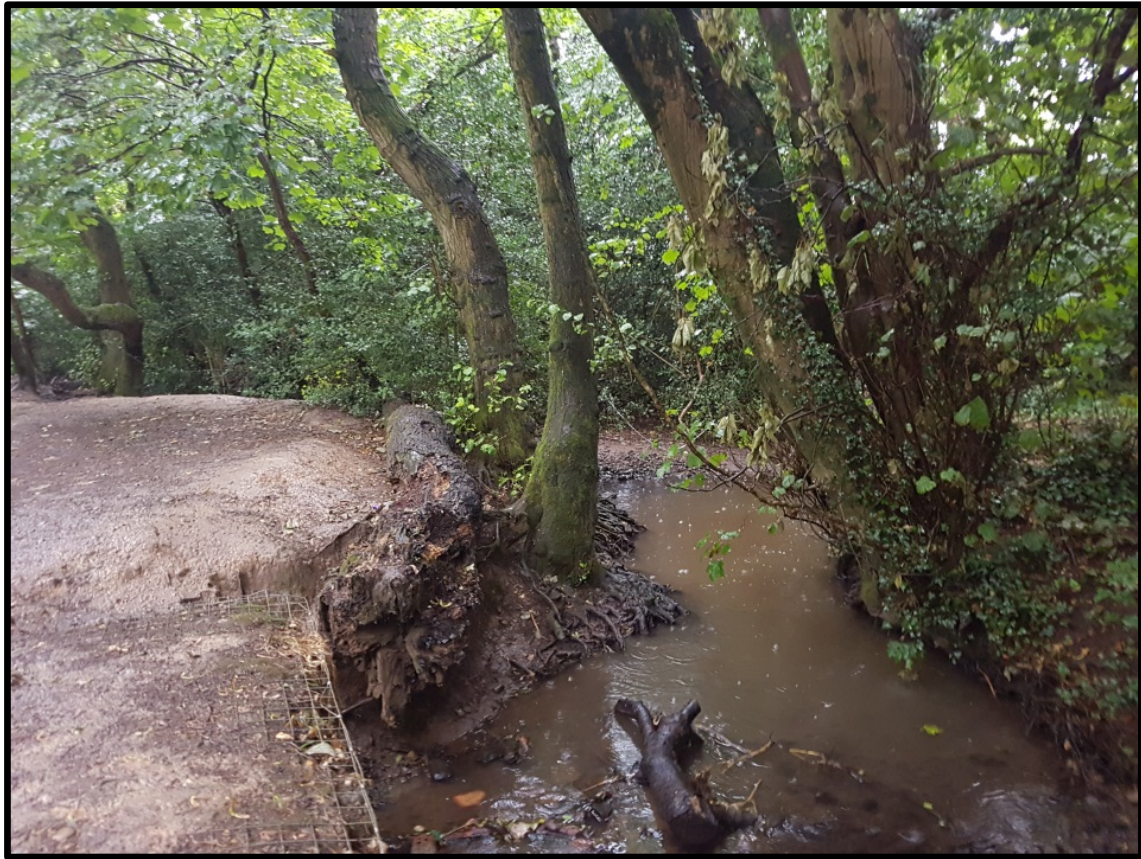
**Figure 5 Tree roots and undercut banks at Nant Fawr, downstream of Llanishen Reservoir**

Downstream of Llanishen Reservoir, the Nant Fawr flows through open parkland and deciduous woodland, with fluvial features similar to that seen upstream: a sinuous reach with fine and large roots, undercut banks and large cobbles were among the crayfish refuges searched (Figure 5). The Nant Fawr survey reaches were however affected by urban discharges from surface water drains which became active during the survey. The sediment load of the substrate in the lower survey reach was high, often smothering crayfish habitat.

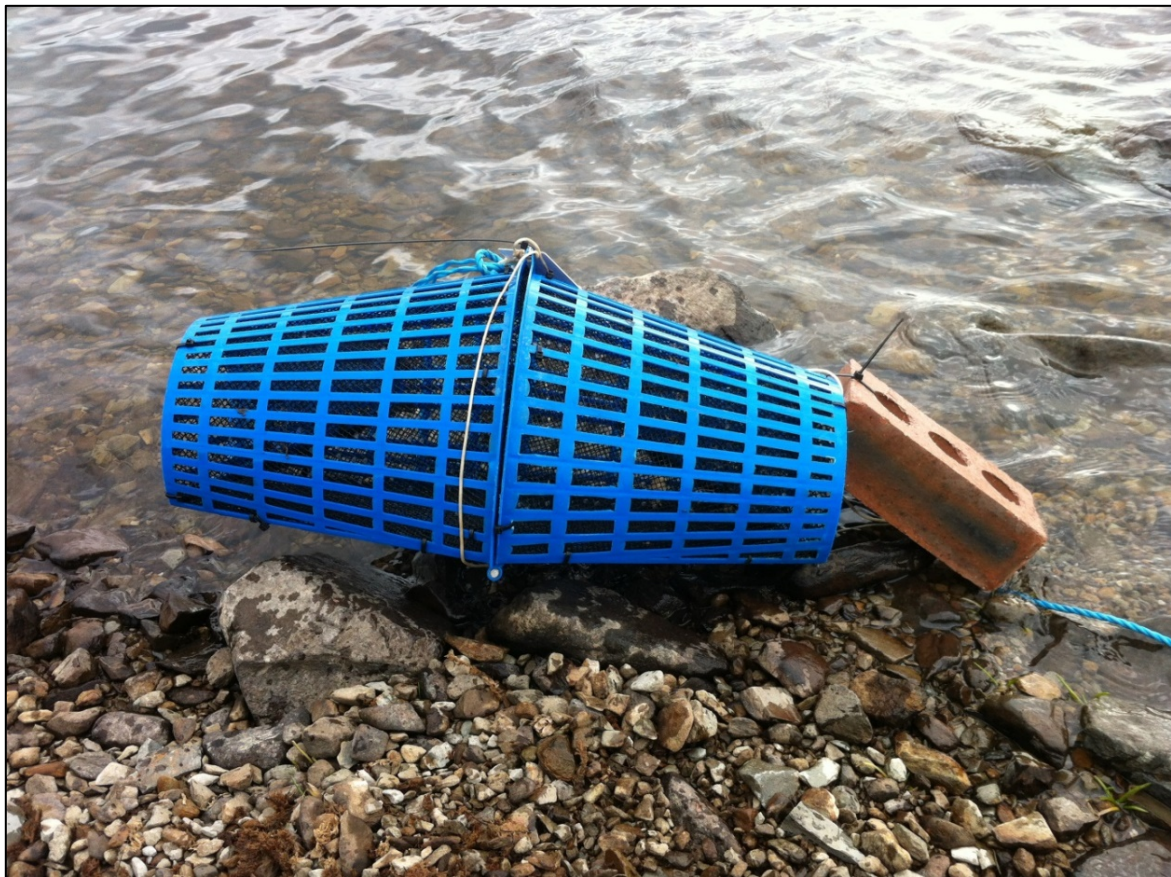
Figure 6 Example of a baited crayfish trap.

In deeper reservoir water, where manual surveys were not feasible, crayfish traps were baited with oily fish and set at depths ranging from 1 to 3.5m (Figure 6). Traps were set with otter-proofing to prevent entrapment of otters foraging in and around the reservoirs. Traps were marked with a fluorescent orange buoy to aid in retrieval and deployed by a small inflatable boat at suitable locations within the reservoir (Figure 7). Traps were left for 24 hours and retrieved the following day.
