Lisvane and Llanishen reservoirs: Survey of grassland fungi 2017

Dwr Cymru Welsh Water

APEM Ref. P00001937

February 2018

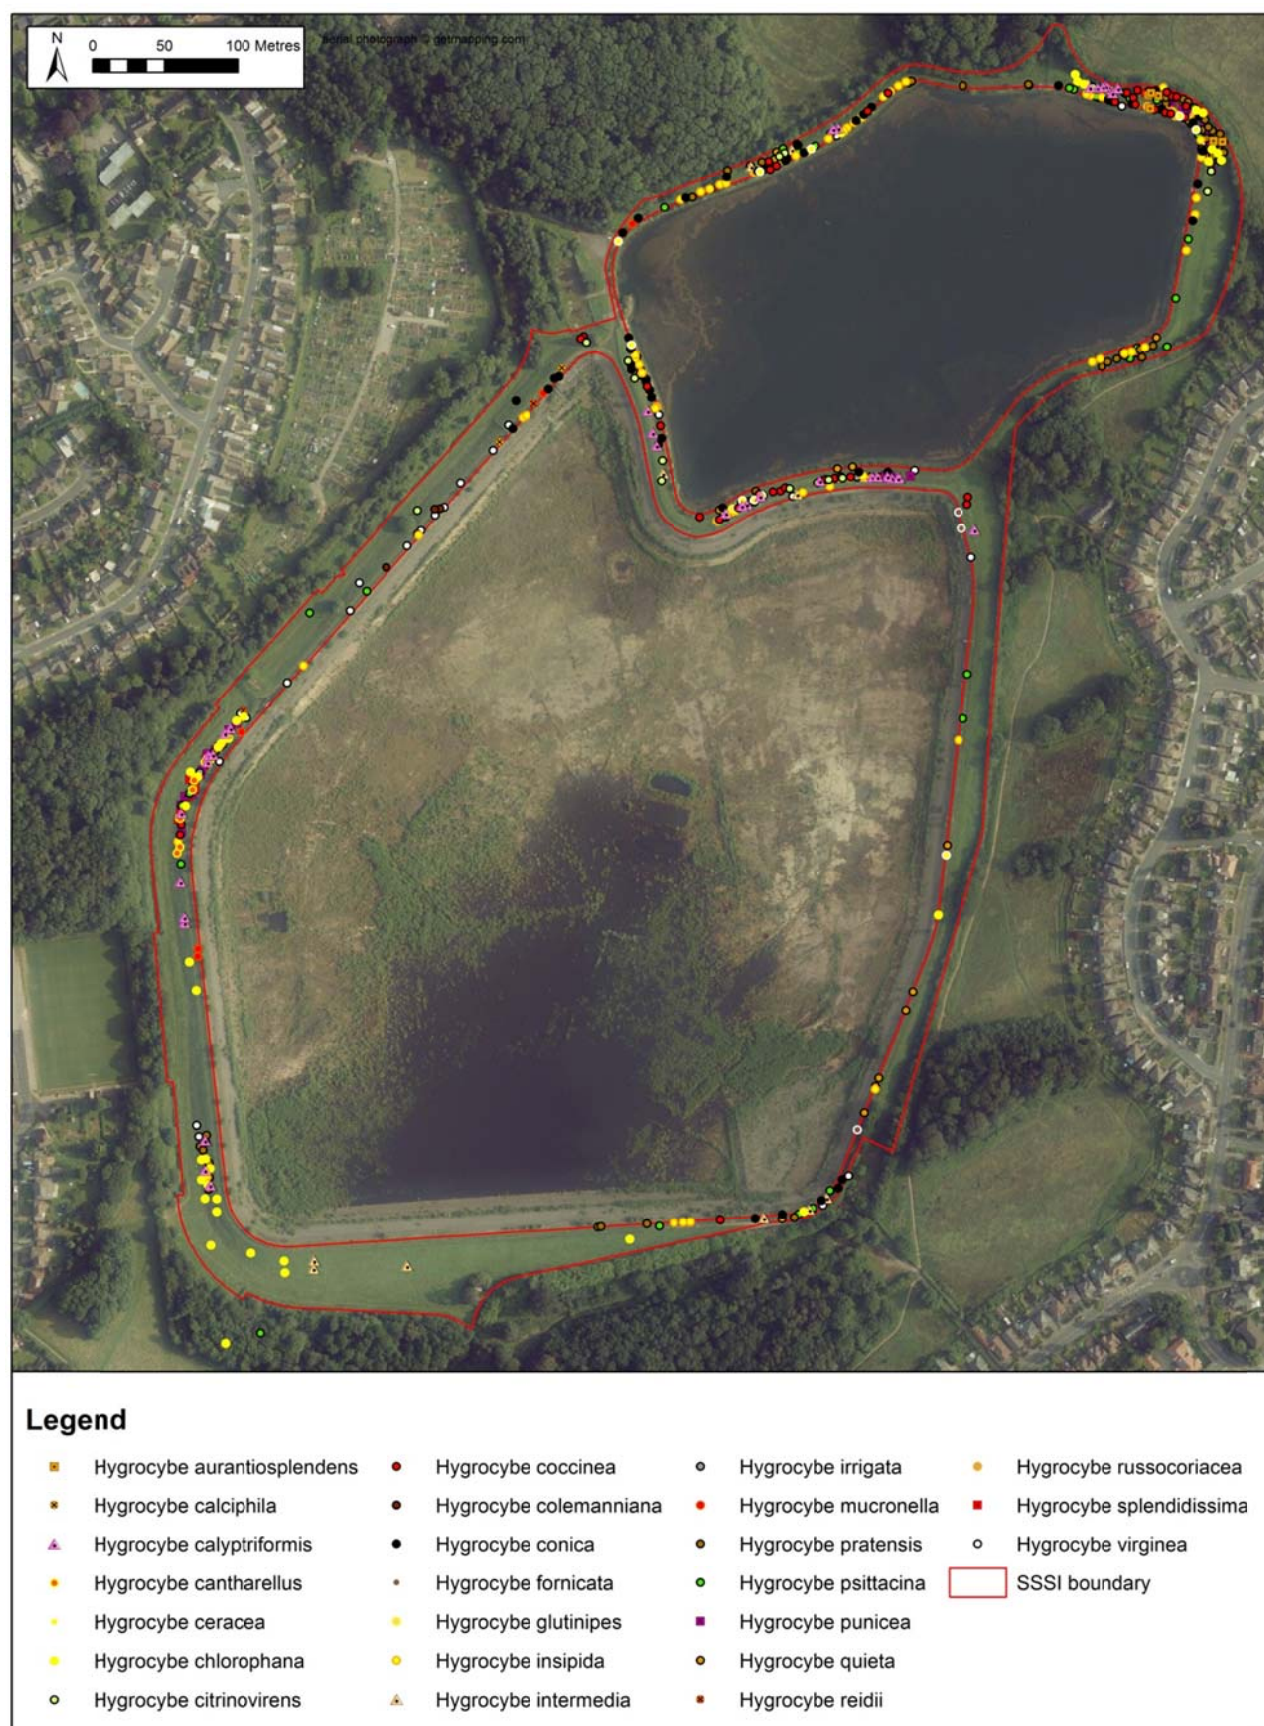
Figure 1 Summary plot showing distribution of waxcap fruiting bodies seen during 2017

The distribution of the waxcap fungi is shown in Figure 1 and non-waxcap target species in Figure 2, showing locations where the fruiting bodies were seen during all six survey visits, and during other site duties. Note that the scale used and degree of overlapping symbols does not permit the individual species to be seen clearly in the figure, and it is mainly intended to highlight the locations where the main groups of fruiting bodies were seen (a more detailed figure is available if required).

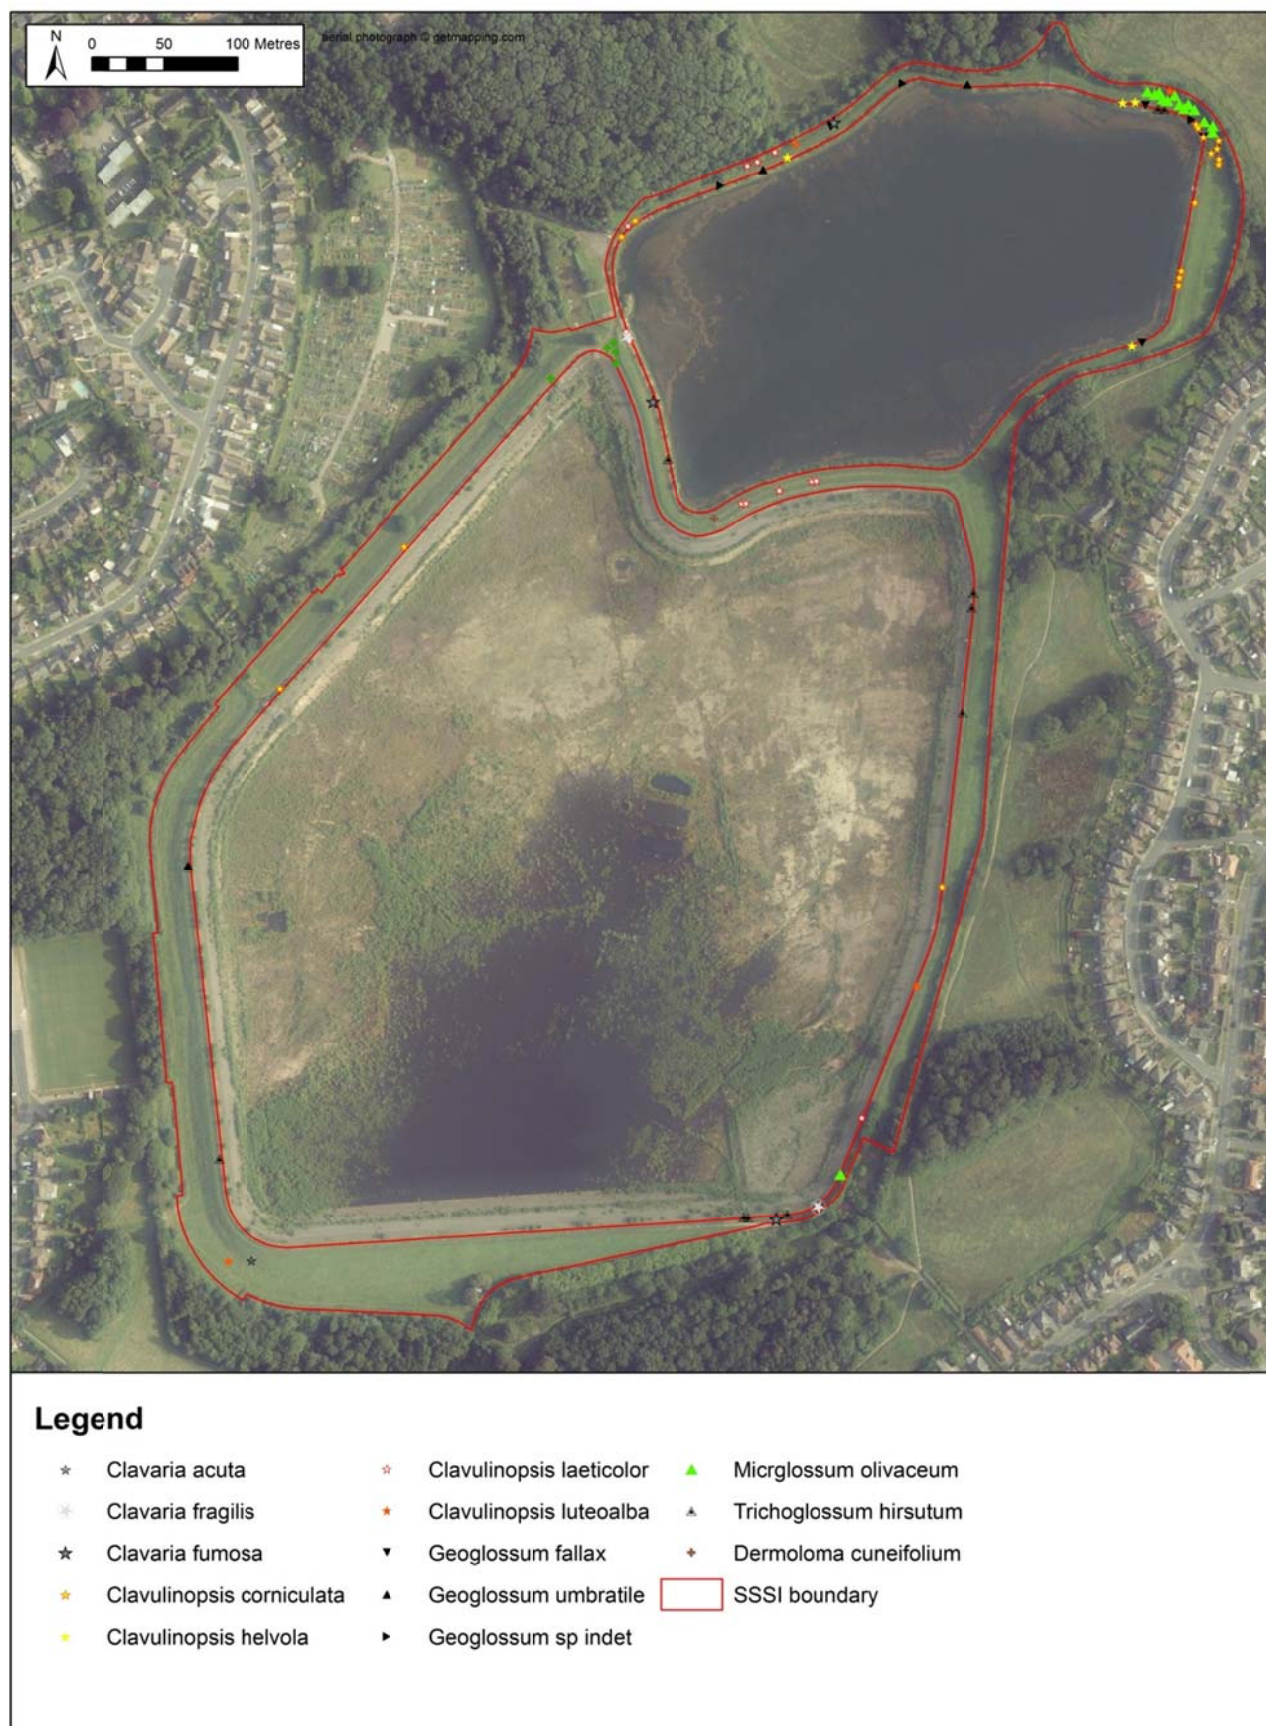
Figure 2 Summary plot showing distribution of other indicator fungi seen during 2017

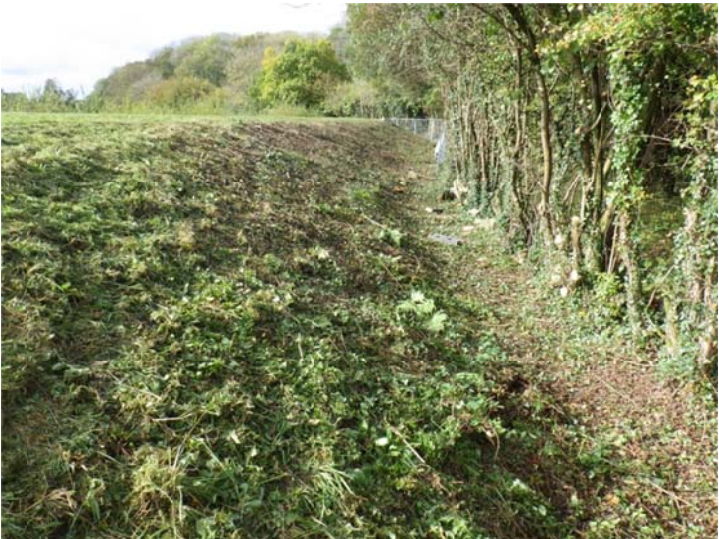
<p>Embankment north of Lisvane Reservoir following removal of encroaching scrub.</p>
17

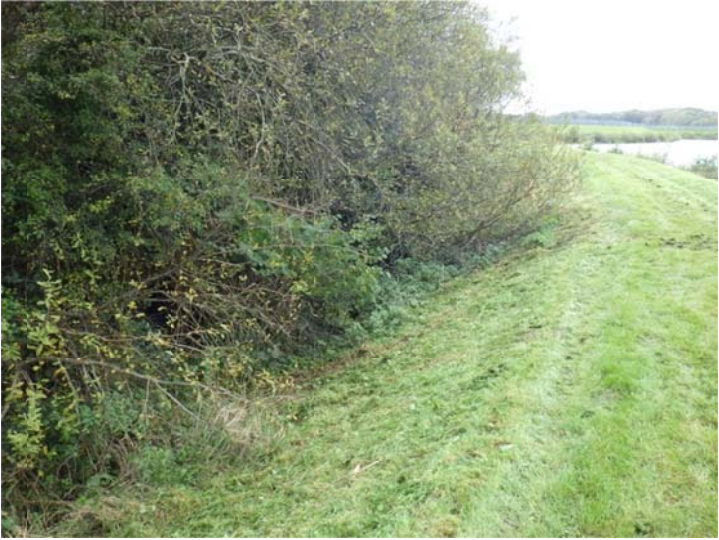
<p>Encroaching boundary hedge east of Lisvane Reservoir, recommended for clearing back to the boundary in 2018.</p>
18

There has been good progress in recovering the area of waxcap grassland habitat that had been lost to shading by trees, but there is still more to be completed. It is recommended that the hedges adjacent to Lisvane Reservoir and along the eastern side of Llanishen Reservoir should be cut back to the site perimeter. Special care should be taken when working beside the north-east side of Lisvane Reservoir because some of the best waxcap grassland extends right up to the hedge. All cuttings should be removed from the grassland.

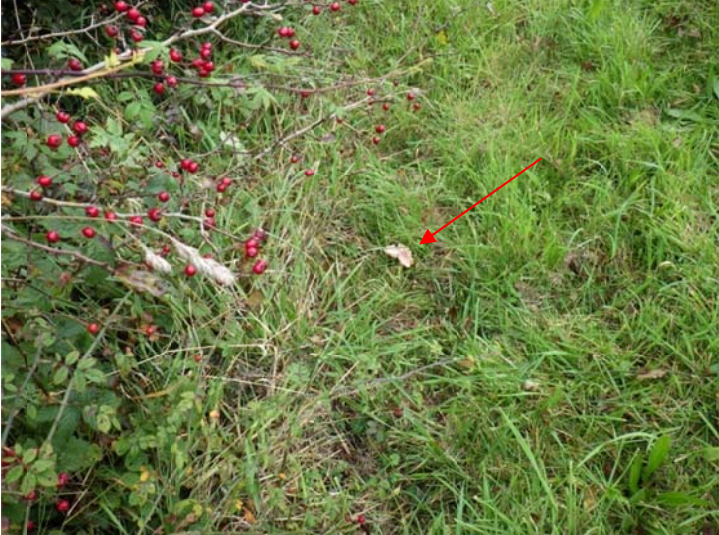
<p><i>Hygrocybe calyptriformis</i> at base of hedge north of Llanishen Reservoir (October 2017). Species in this situation are very vulnerable to becoming shaded out by scrub encroachment.</p>

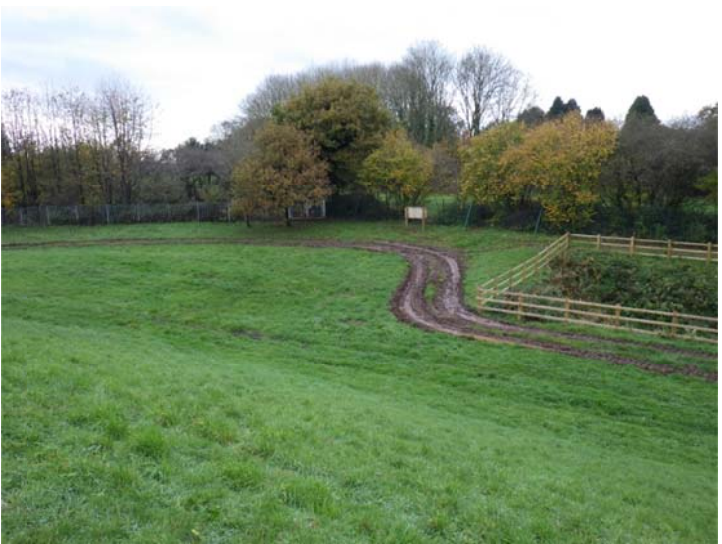
<p>The construction access around the edge of the SSSI has mostly avoided areas of value for fungi, but has probably caused local disruption to species south west of Llanishen Reservoir (October 2017).</p>

The access track around the SSSI perimeter is likely to have damaged the grassland fungi in the areas where it was routed. In general it was routed across the lower grassland areas where there were relatively few waxcap records. However, it did pass through the patch of slightly acidic grassland to the south-west of Lisvane Reservoir where *H. laeta* was regularly recorded in previous surveys. The absence of this species from the 2017 survey may be due to the presence of the track. However, the absence of this species from any other parts of the site during 2017 may just mean that it was a poor year for this species.

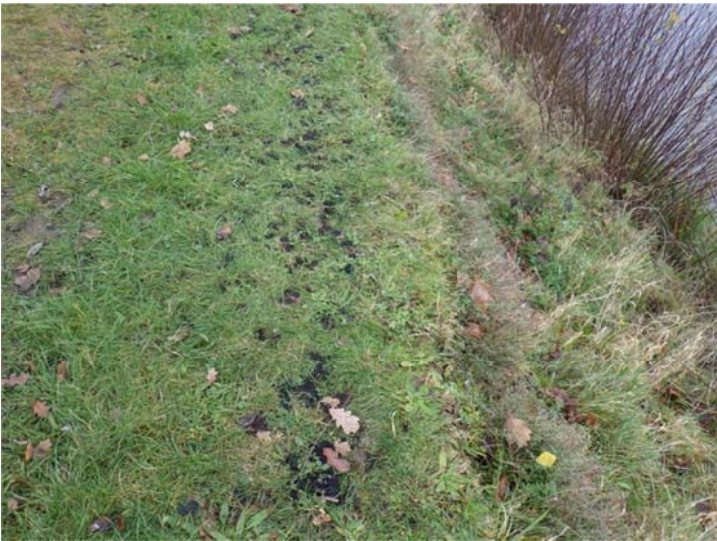
<p>Goose droppings and trampling of grass on the north side of Lisvane Reservoir in late-October 2017. Possibly indicating another change of roosting site following removal of scrub from the adjacent boundary, and ongoing works in Llanishen Reservoir. This area produced moderate numbers of fungi earlier in the season but very few have been seen since the arrival of the geese.</p>
27

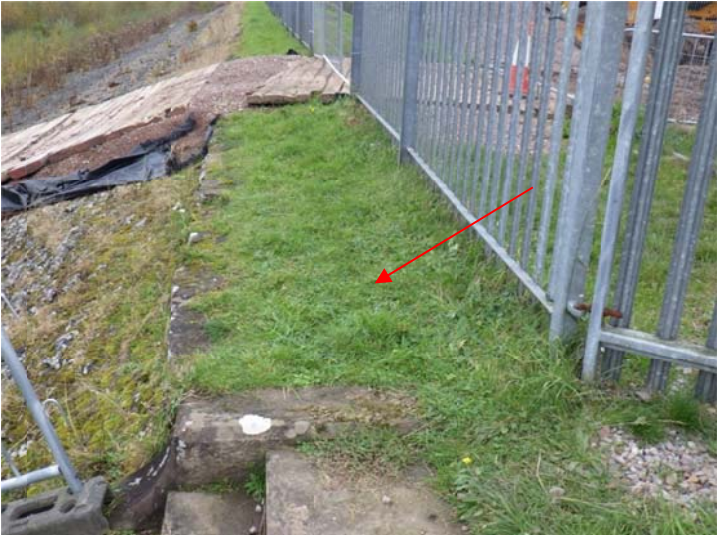
<p>A new location for <i>Microglossum olivaceum</i> was found in short grass near to the Lewis site compound south-east of Llanishen Reservoir. For the last few years this strip of grassland has been protected from trampling and dog-fouling by the palisade fence. (October 2017).</p>

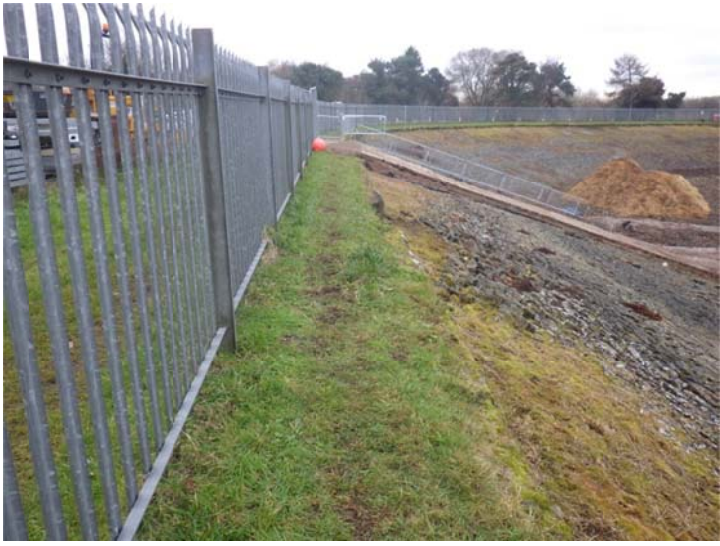
<p>Since work started on clearing the reservoir base, the grass inside the palisade fence has become more trampled, and no more fungi have been found along this strip. This is probably just a temporary effect, provided that the trampling does not become any heavier (November 2017).</p>
29

The palisade fence around the Llanishen Reservoir perimeter should be removed, so that the grass at the top of the stonework can be mown properly. This would also remove the sheltering effect; creating harsher conditions that would limit the dominance of coarse grasses, and help to disperse grass cuttings from the top of the banks. However, measures should be put in place to ensure that the edge of the grassland beside the stone pitching does not become heavily trampled.

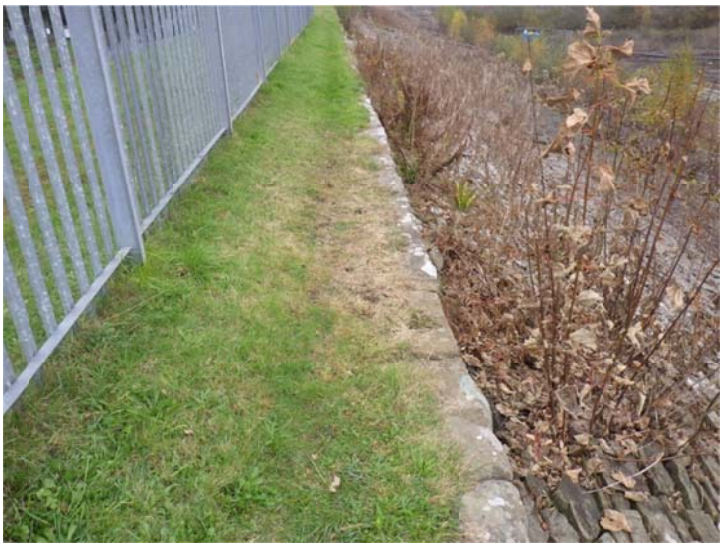
<p>Herbicide damage by spray drift into SSSI grassland west of Llanishen Reservoir (November 2017). This strip beside the stone pitching is known to support moderate numbers of fungi. Glyphosate is known to be harmful to waxcaps, but the extent of any impact here (and at several other locations around the stone pitching) is not known yet.</p>
30

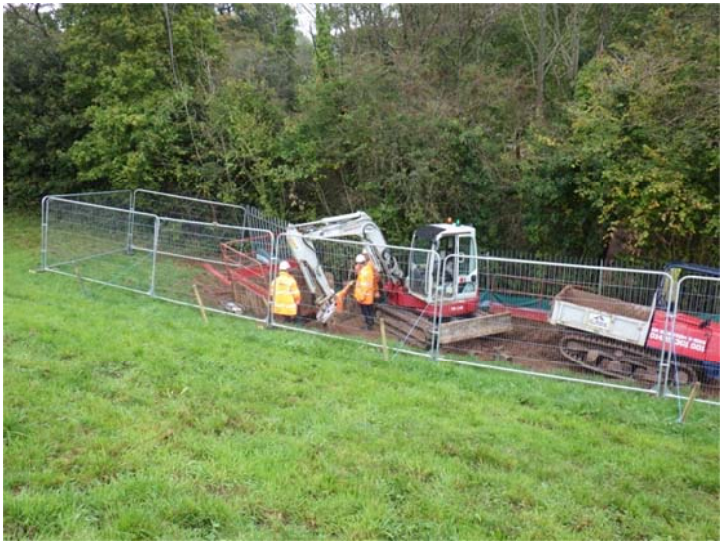
<p>The route initially proposed for construction access to repair a valve at the east side of Lisvane Reservoir would have resulted in the loss of the most diverse assemblage of fungi in the SSSI. An alternative route was subsequently gained via the adjacent footpath which minimised loss of grassland and avoided the disruption to any known waxcap locations.</p>

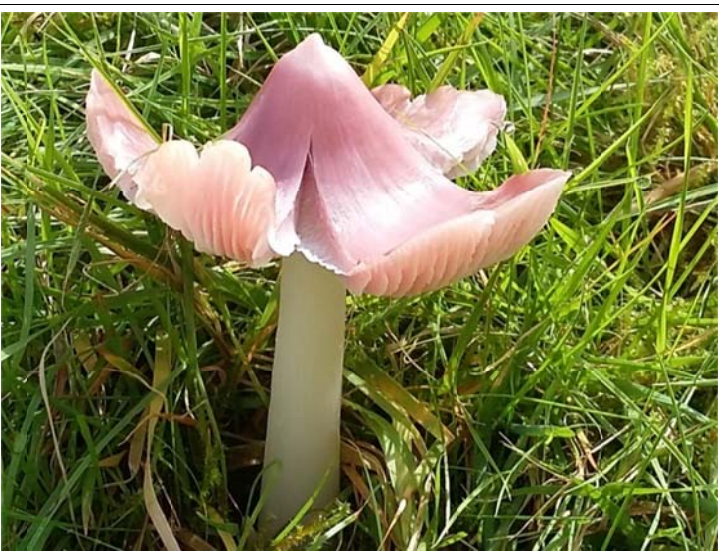
<p><i>Hygrocybe calyptriformis</i> was found during every fungi survey visit in 2017.</p>
32

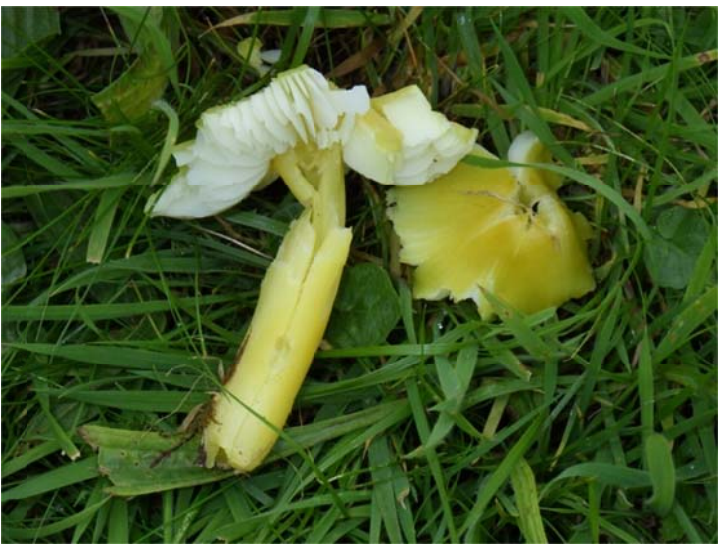
<p>Observations in August and September confirmed several new locations for early-fruiting species such as this <i>Hygrocybe citrinovirens</i>.</p>
33

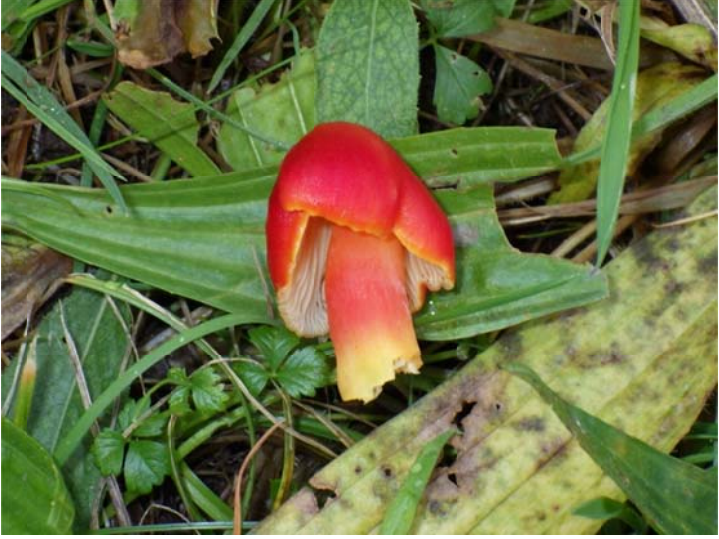
<p><i>Hygrocybe splendidissima</i> was found in several patches on the western embankment. This is its first recorded appearance at the site since 2006.</p>

The re-appearance of *H. splendidissima* at the reservoirs for the first time since 2006 is also a good illustration of how fungi can remain undetected in the soil for many years.
